Bard Meridian Filter Fracture

Citation	Wu, Alex et al. "Bard Meridian Filter Fracture." CardioVascular and Interventional Radiology 38.1 (2015): 251–252.
As Published	http://dx.doi.org/10.1007/s00270-014-0935-9
Publisher	Springer US
Version	Author's final manuscript
Accessed	Fri Jan 27 21:25:18 EST 2017
Citable Link	http://hdl.handle.net/1721.1/103315
Terms of Use	Article is made available in accordance with the publisher's policy and may be subject to US copyright law. Please refer to the publisher's site for terms of use.
Detailed Terms

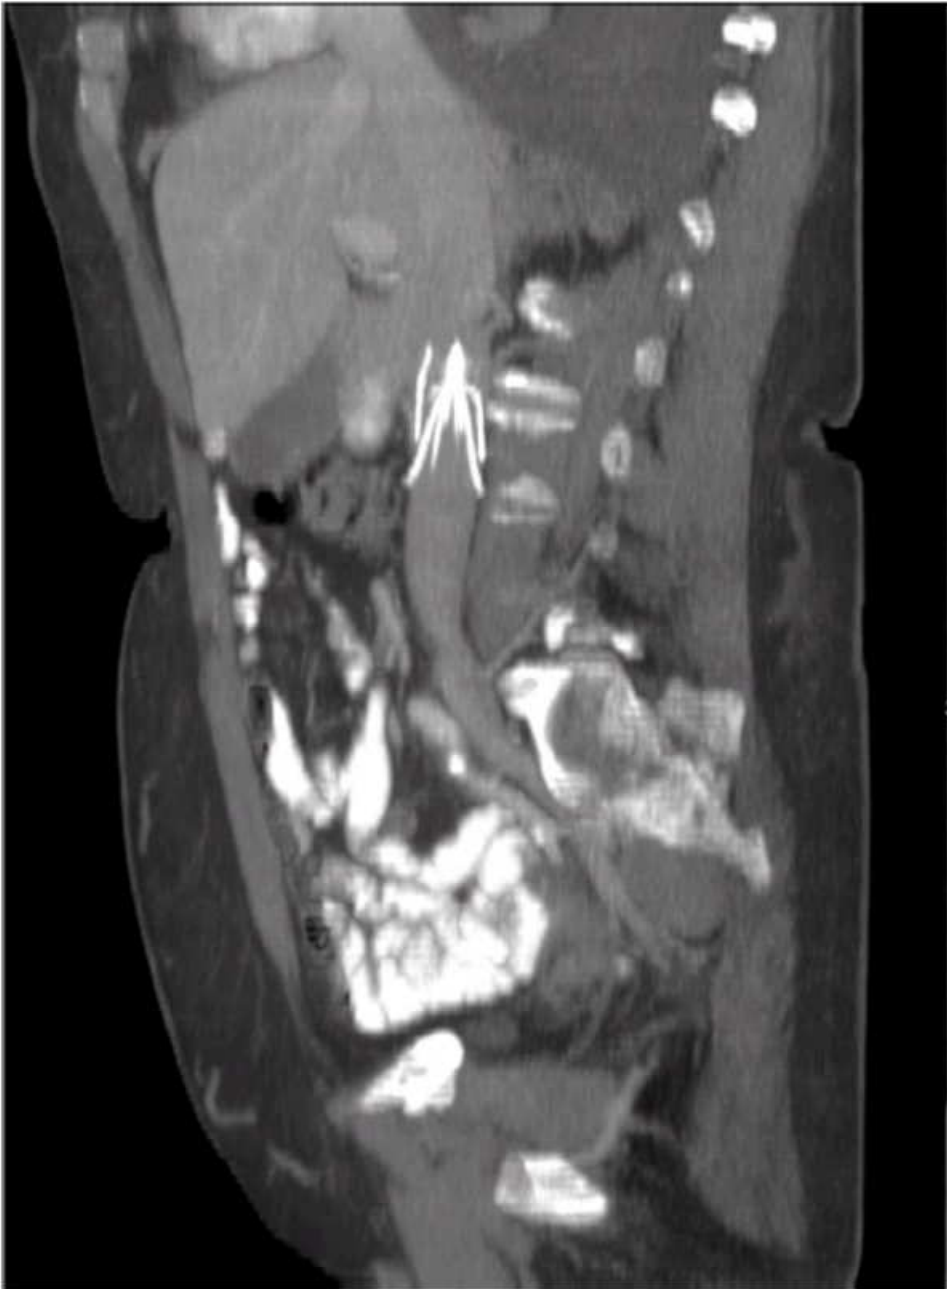
Figure 1. Sagittal maximum intensity projection (MIP) CT image at one-year follow-up demonstrates fracture of a single limb of a Meridian IVC filter (white arrow) with cephalad strut migration of approximately 1 cm in the IVC.

The patient had multiple CT scans thereafter for cancer follow-up. A contrast-enhanced CT scan of the abdomen and pelvis (Fig 1) performed 368 days after the initial placement of the Meridian filter demonstrated fracture of a single arm (short limb) of the IVC filter, with cephalad migration of the fractured limb to approximately one cm superior to the filter apex in the IVC. The filter was otherwise well positioned without significant tilt or migration. No thrombus was present, and the patient was asymptomatic. Review of the CT scan of the abdomen performed at eight months after the procedure demonstrated no filter fracture, suggesting that the fracture occurred 8 to 12 months after the filter was placed. Although the interventional radiology service recommended retrieval of the fractured filter, this procedure was not performed because of the patient's desire for conservative management.
